DYNAMIC AND ENVIRONMENTAL EVALUATION OF
COMPLAINT FOIL GAS LUBRICATED BEARING

Airesearch Manufacturing Company of Arizona

Air Force Aero Propulsion Laboratory

AFAPL-TR-73-56

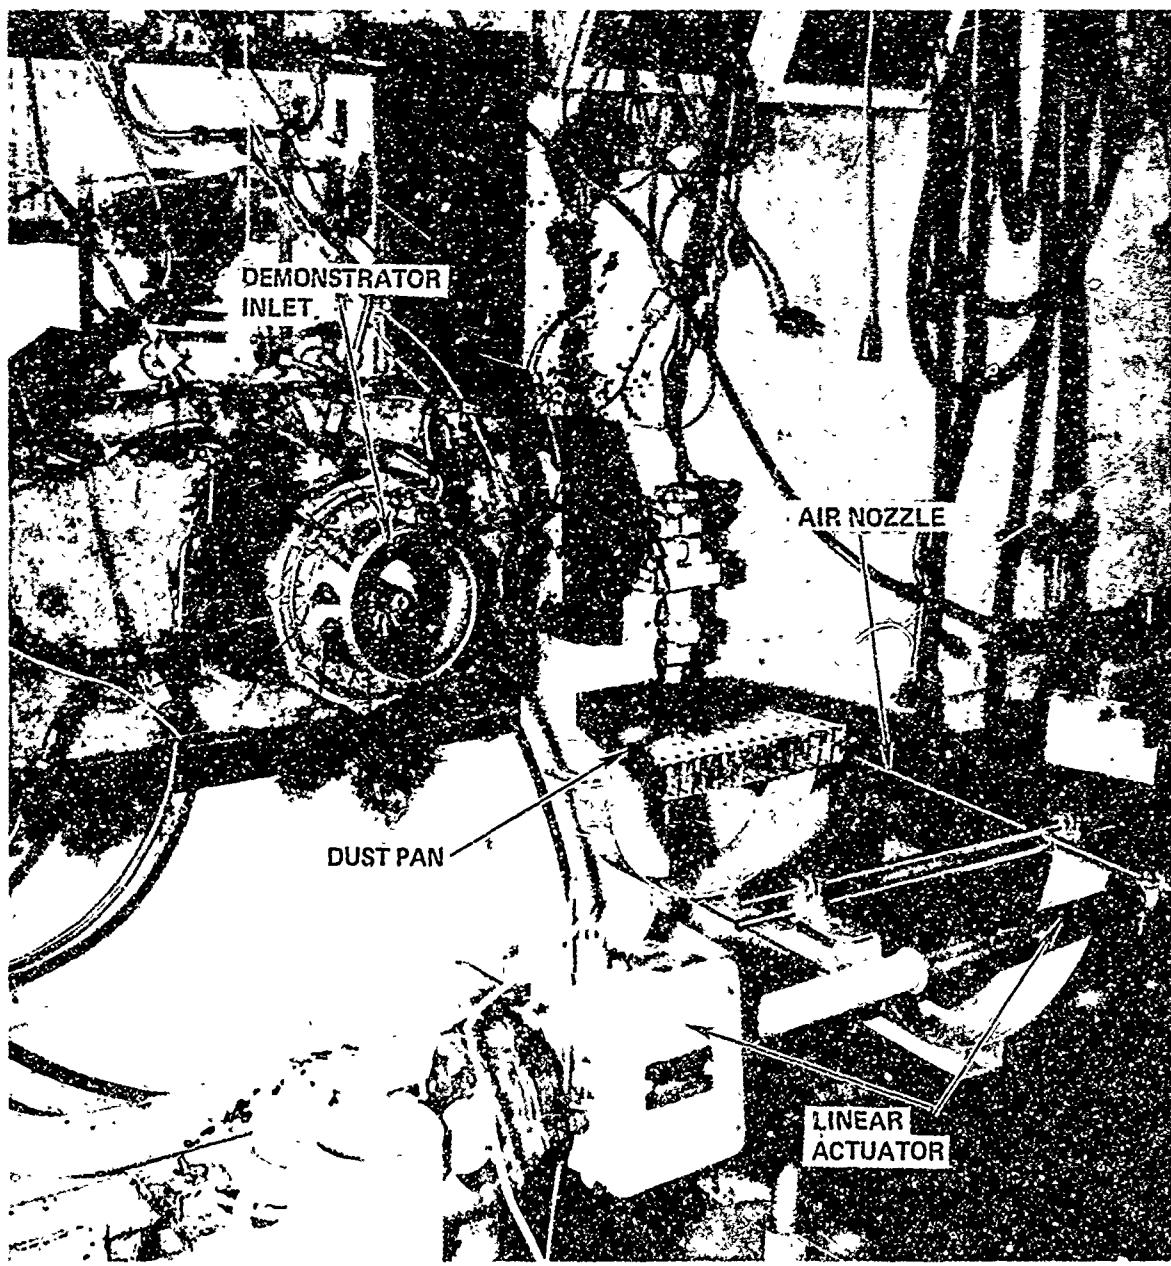
Figure 19. Foil bearing demonstrator and dust ingestion mechanism prior to dust ingestion test.

Following the test, the unit was disassembled for inspection. Figure 20 shows two sample journal bearing foils: one from the turbine-end bearing and the other from the compressor-end bearing. The foils were in excellent condition. Normal minor discoloration at the foil tips, where they experience the greatest soakback temperatures (540°F in this test), and some glaze, which accompanies "bedding in", were evident. Shallow scratches, particularly the axial ones, could be seen on the foils. These may have been caused by trapped dust particles being rolled along the foils as the shaft was withdrawn during disassembly.

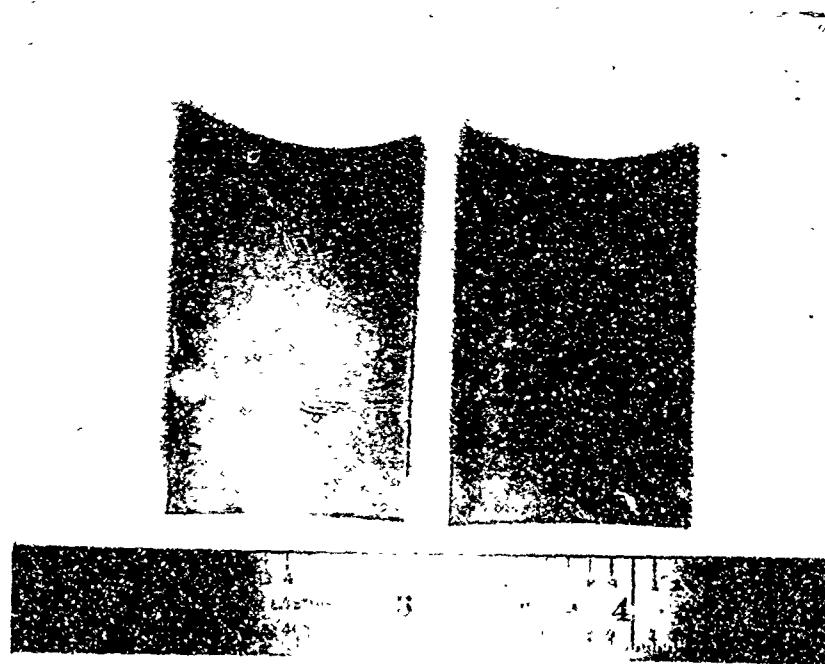
Figure 20. Journal bearing foil segments
after dust ingestion test.

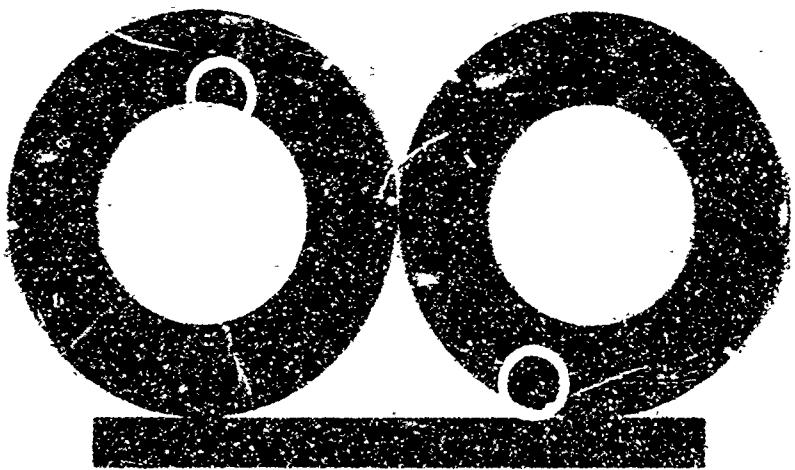
The forward and aft thrust bearing assemblies are shown in Figure 21. The circled portions of each, magnified ten times, are shown in Figure 22. As with the journal bearing foils, both thrust bearing assemblies were in excellent condition. Some of the dust particles were embedded in the foil coatings; the rest of the dust seemed to have had little effect on the bearings, other than leaving minor scratches. Some local charring was evident on all of the bearings, as was noticed after the water ingestion test.

Figure 21. Forward and aft thrust bearing assemblies after dust ingestion test.

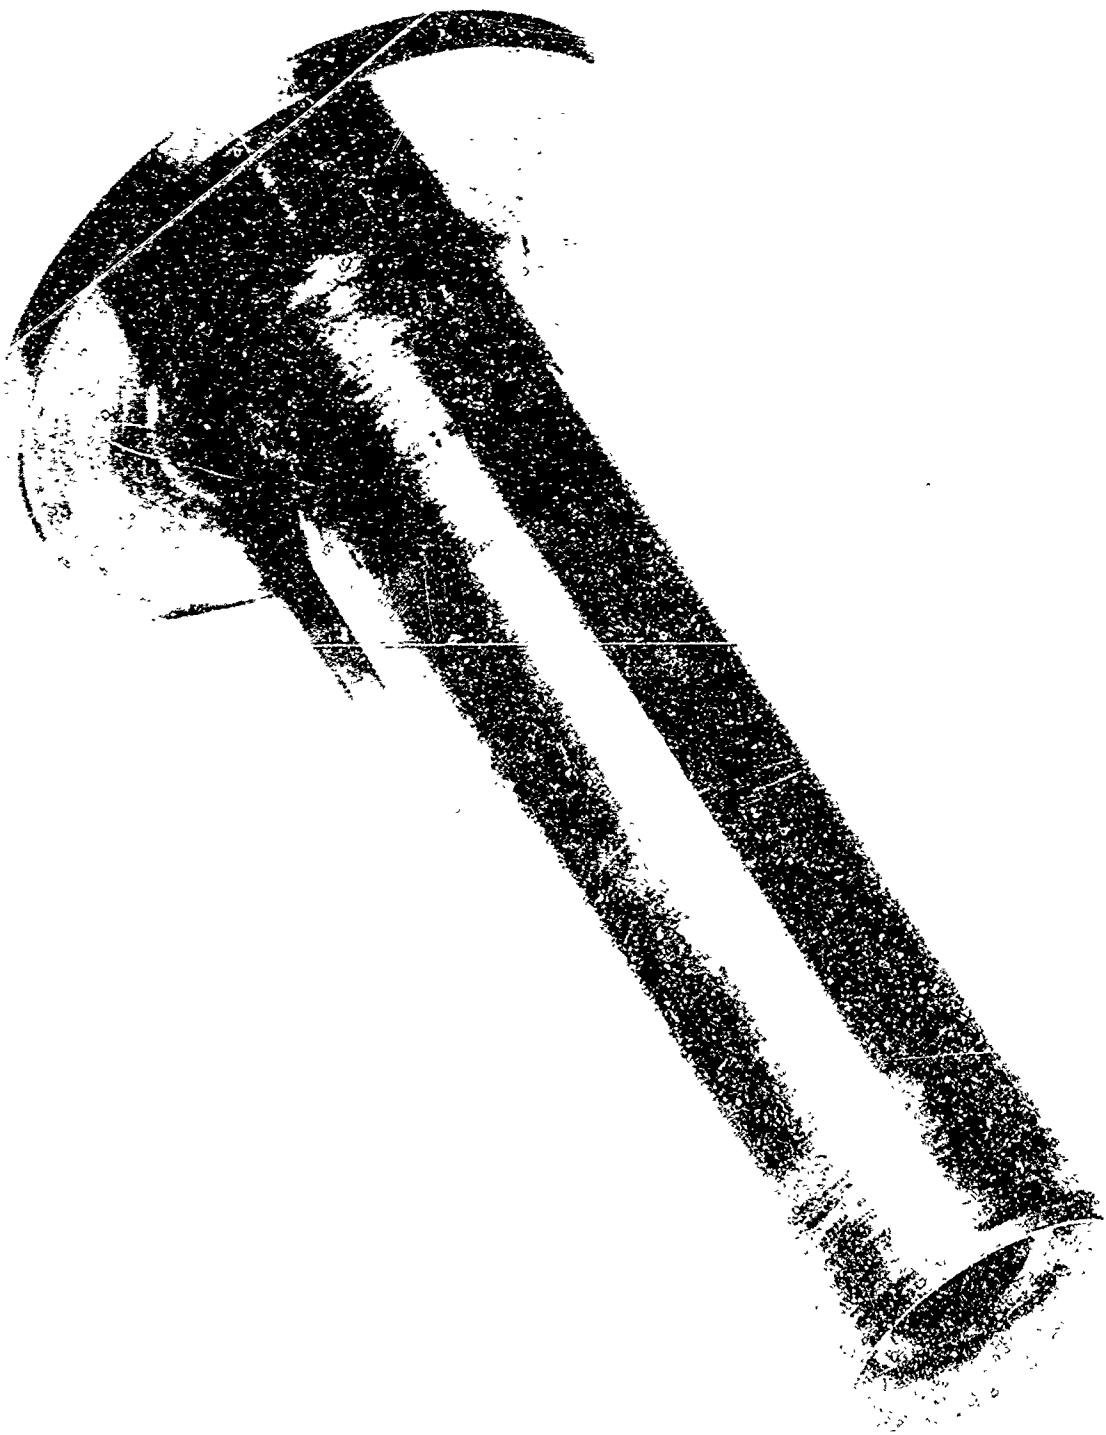
Following the test, the unit was disassembled for inspection. The compressor-end foils are shown in Figure 24, the turbine-end foils in Figure 25, and the journal shaft/thrust runner assembly in Figure 26. Failure appeared to be the result of corner loading the bearings in excess of the load capacity that they could hydrodynamically sustain under the test shaft speed and bearing environment.

Figure 26. Journal shaft/thrust runner assembly after maneuver load test.

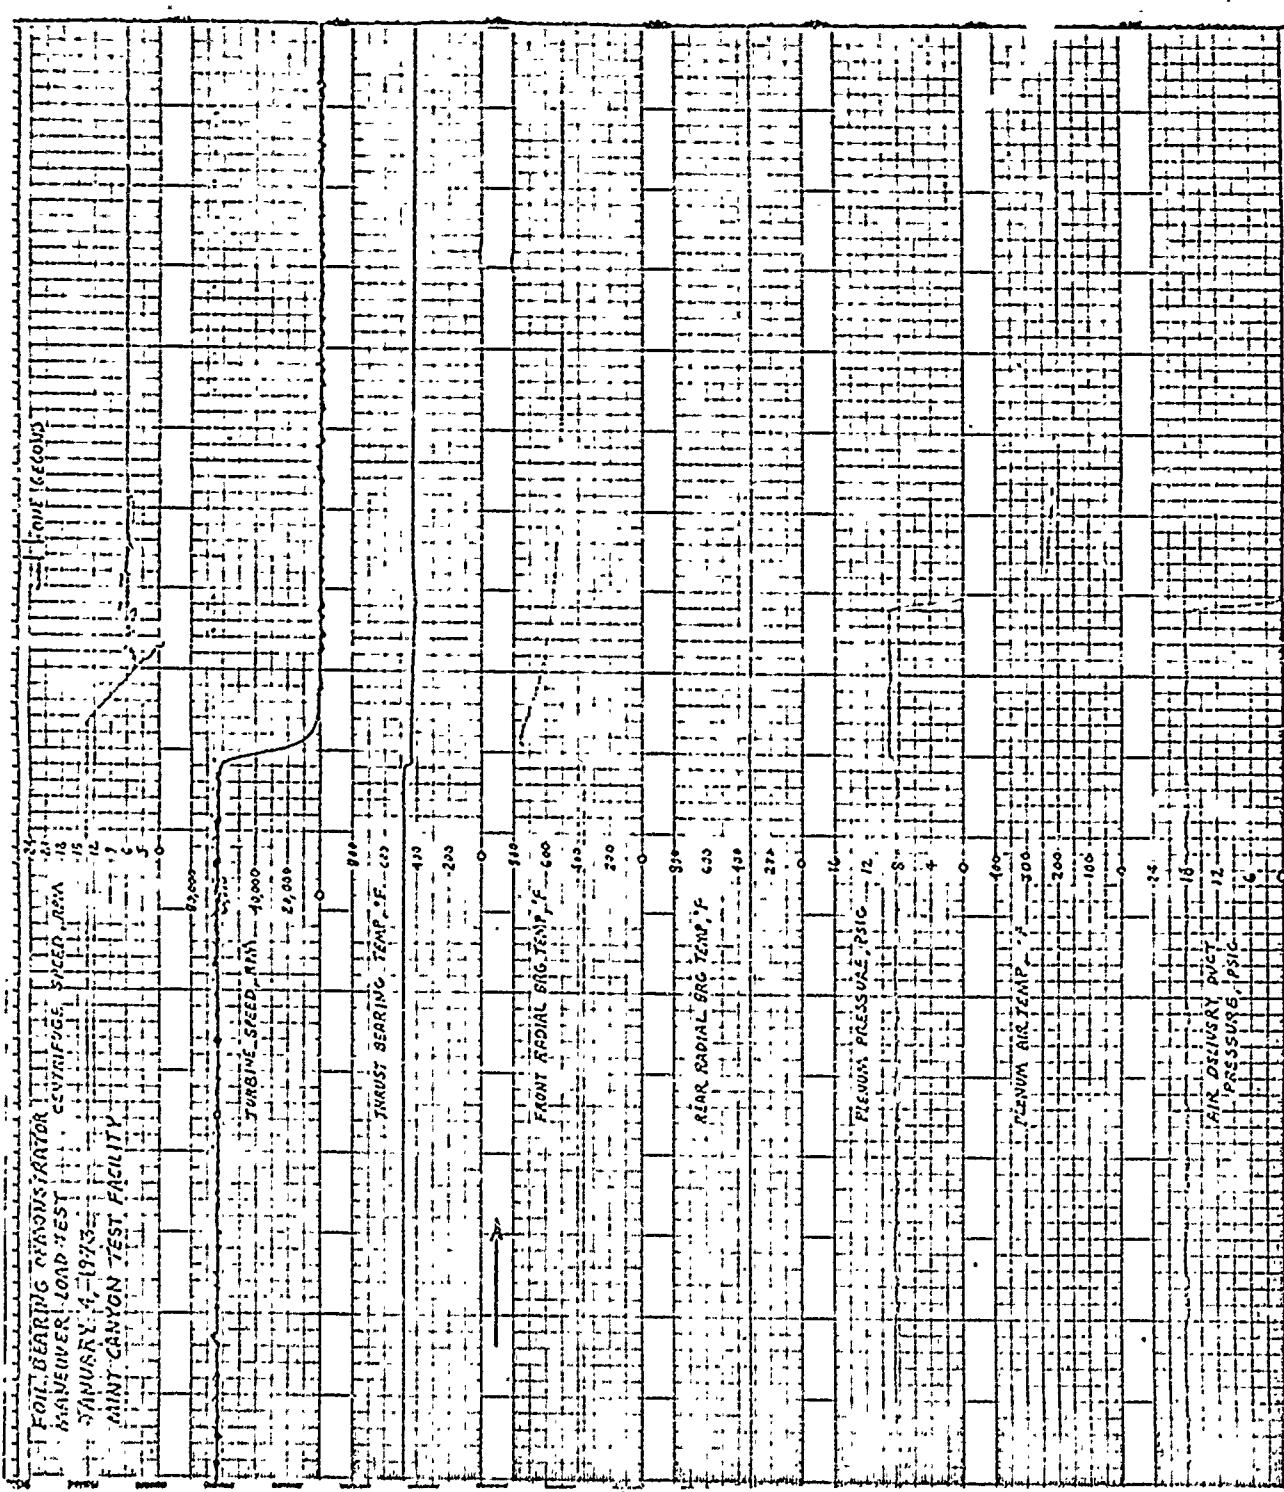
Figure 33

The centrifuge was started, idled at 3 rpm, and then the speed was increased in increments of about 1 rpm. With the demonstrator oriented as shown in Figure 29, the compressor end of the rotating group was forced down and the turbine end up due to the induced gyroscopic movement. At a centrifuge speed of 13.6 rpm, the ultimate load capacity of the compressor-end journal bearing was exceeded. Shaft contact with the foils resulted in a sharp rise in temperature, culminating in seizure. The Offner recording of the last seconds of the test is presented in Figure 33.

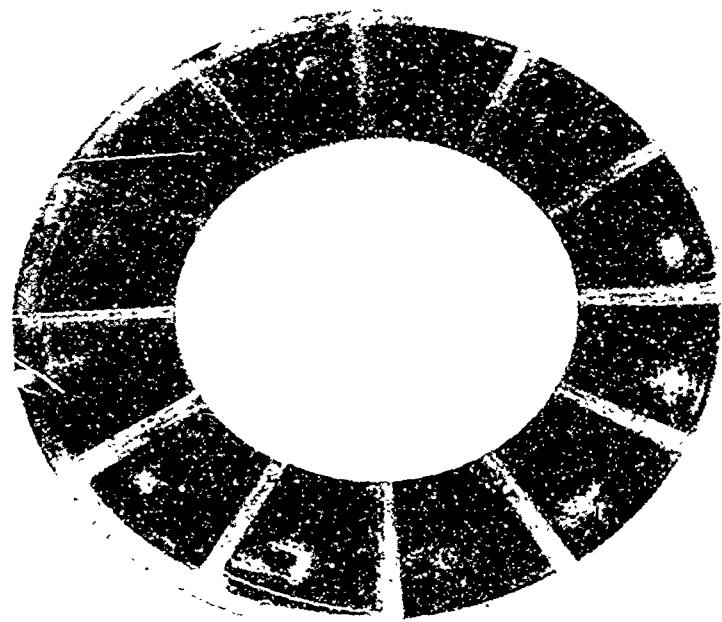
The demonstrator was returned to Phoenix where it was disassembled and inspected. The failure of the compressor-end journal bearing was verified, but the turbine-end journal bearing was still in good condition. The coating on both sides of the thrust bearing was damaged from excessive heat, appearing somewhat like the thrust bearing that underwent the checkout bench test at Phoenix (Test 2). It is felt, however, that both these thrust bearings were damaged after the tests were completed, due to soakback of heat generated during the compressor journal bearing seizure, since neither the foil metal nor the backing plates displayed distress. Figure 34 shows both sides of the thrust foil bearing and Figure 35 shows the compressor side of the thrust runner. Figure 36 shows the turbine-side of the thrust runner, along with the turbine end of the journal shaft, which was still in excellent condition. The shaft was rigidly welded to the compressor-end foils and bearing carrier and could not be pressed out of the carrier. Although a certain amount of welding of the foils occurred during other bearing failures, the shaft could always be pressed out of the bearing carrier.

Figure 34a. Forward thrust bearing surface.

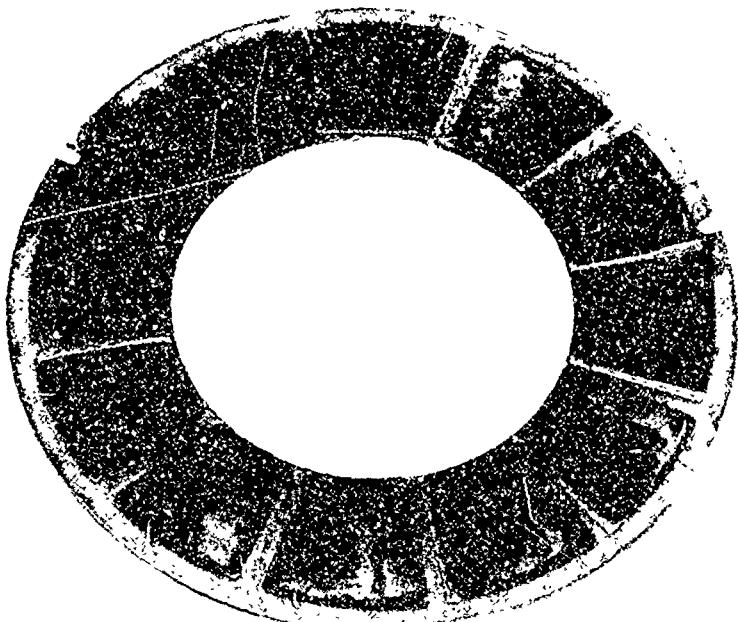
Figure 34b. Aft thrust bearing surface.

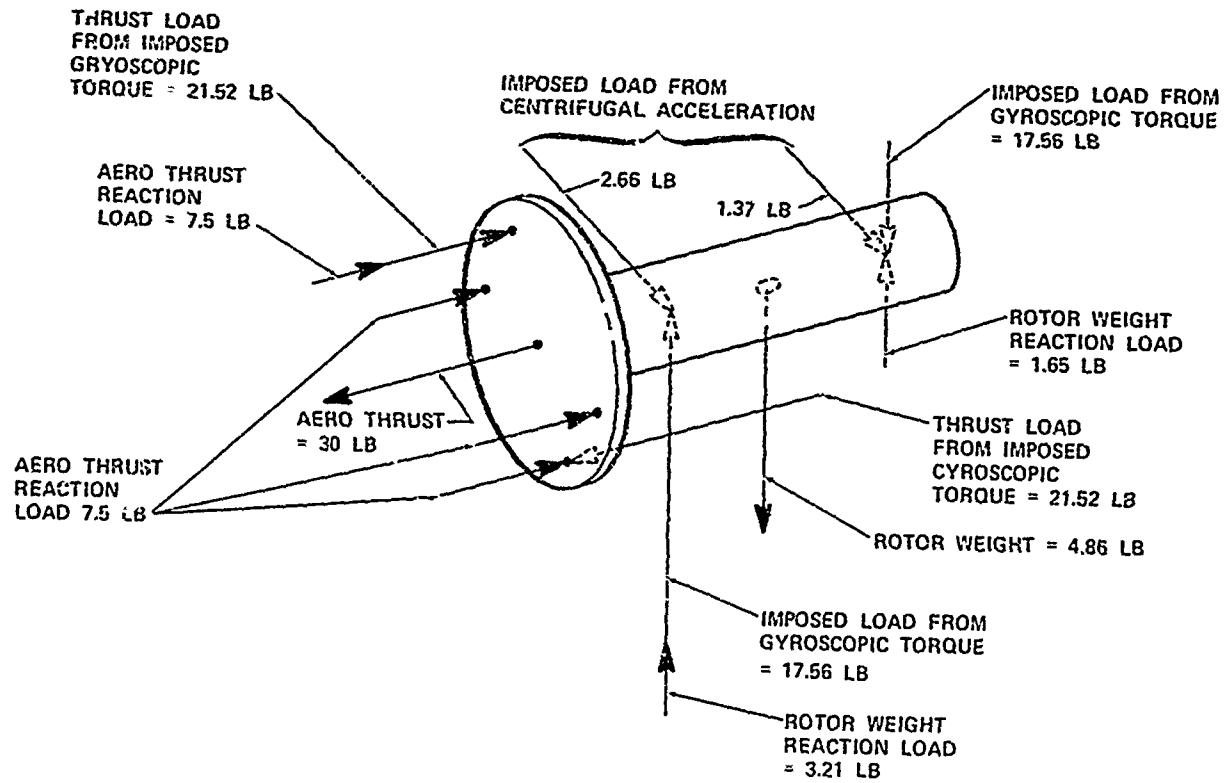
From Table II, the imposed gyroscopic moment on the rotating group was 131.7 inch-pounds. Using a calculated aerodynamic thrust of 30 pounds acting forward on the rotating group, solutions of force and equilibrium equations yield the average loads on the thrust and journal bearings. The solutions are shown in Table III, which indicates the loads on each bearing resulting from the gyroscopic torque, g-loading, and aerodynamic thrust. The last row indicates the total unit loading on the bearings resulting from the combined loading. Figure 40 is an isometric view of the shaft with the direction and magnitude of each source of loading. Of the 131.7 inch-pounds of torque generated, the thrust bearings resisted 61.96 inch-pounds or about 47 percent and the journal bearings resisted 69.74 inch-pounds or about 53 percent of the load just before the load limit of the compressor journal bearing was exceeded.

Figure 40. Isometric diagram of imposed loads upon compressor journal bearing seizure.

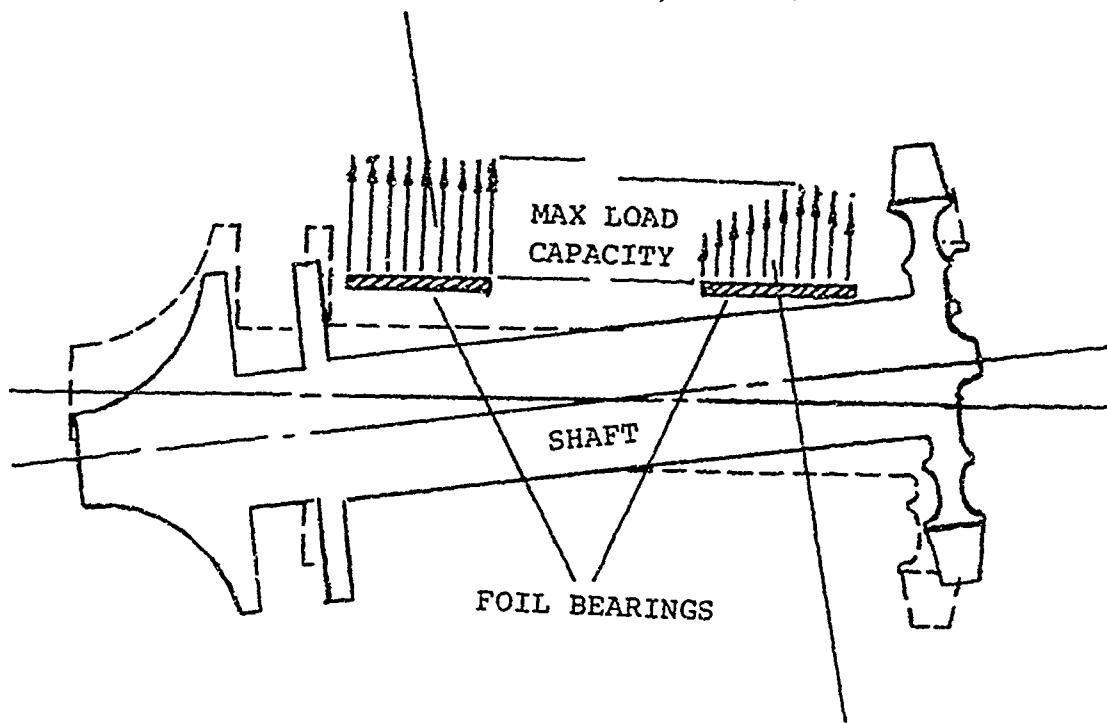
Also, precautions are taken on a test rig to maintain a symmetrical load profile for the bearings and to strive for maximum magnitude of the entire bearing length. Misalignment, angularity, and unsymmetrical loading are avoided during bearing performance tests to obtain repeatable data. When the bearings resist an imposed moment on the shaft, the shaft assumes a skewed position relative to the bearings as shown (exaggerated) in Figure 41.

The loss of capacity in the bearing thus became a measure of its compliancy, or self-aligning capability. The skewed position of the shaft, when resisting a moment loading, decreases the effective area in the bearing that can generate the maximum load capacity. Hence the bearing demonstrates less overall load capacity than is observed in test rig data.

TYPICAL PROFILE FOR
UNIDIRECTIONAL SIDE LOAD
(AS EXPERIENCED DURING BEARING MAPPING)

TYPICAL PROFILE FOR
SKEWED SHAFT OPERATION
(AS EXPERIENCED DURING IMPOSED TORQUE MOMENT)

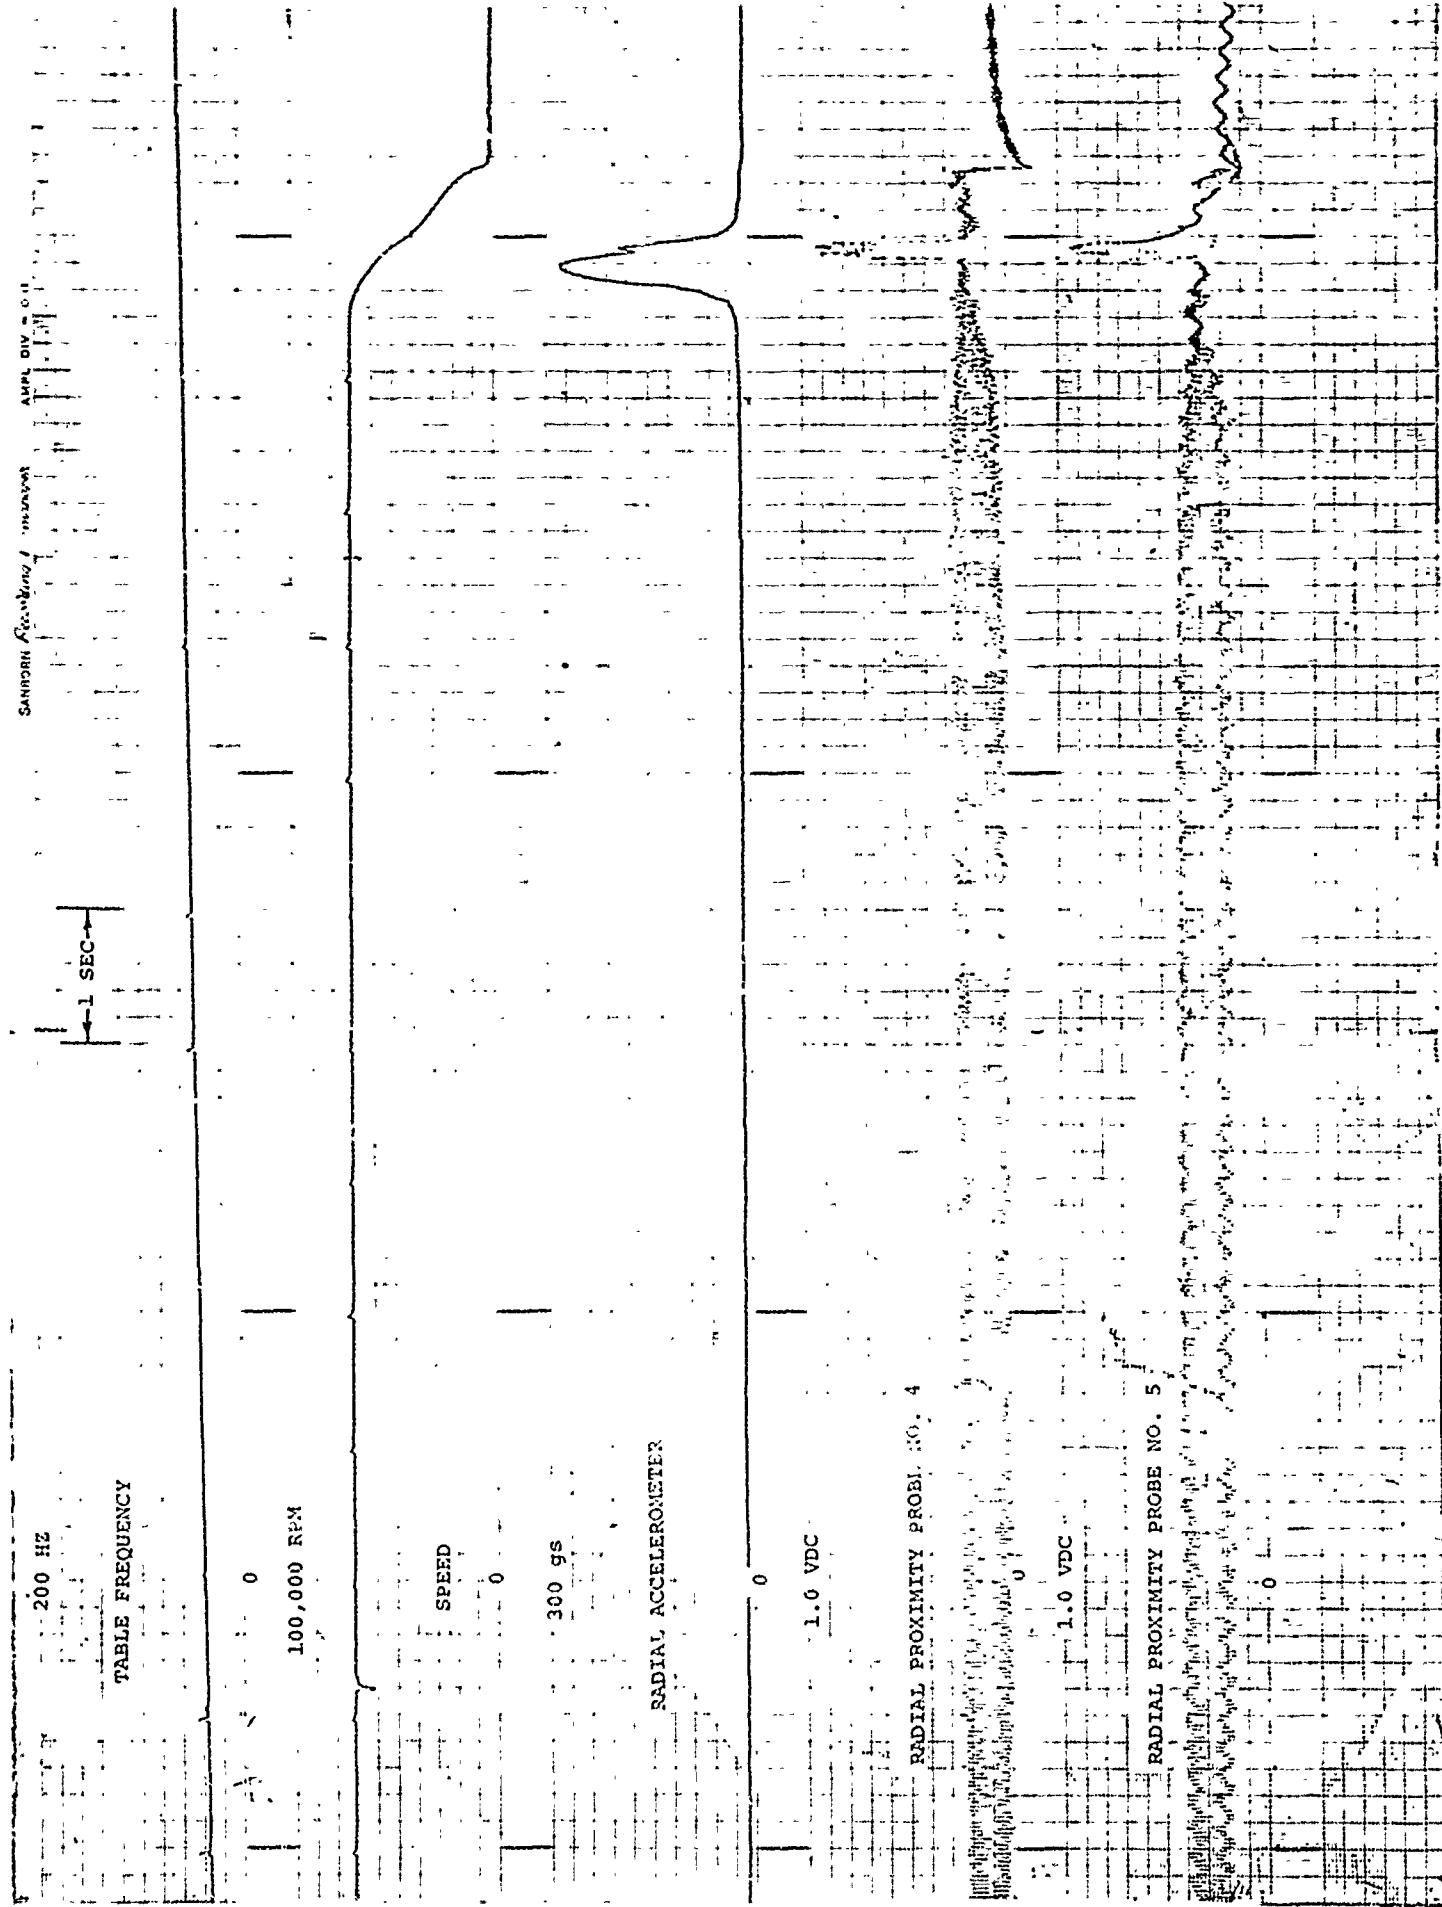
Figure 44. Oscillograph recording of vibration test.

Initial speed drop occurred at an excitation frequency of 53 cps and a table vibration of about 5 g. The total bearing carrier response indicated 28 g: 17 g at 1160 cps and 11 g at 53 cps. Note that 1160 cps corresponds to the engine speed and 53 cps the table-driving frequency. The corresponding amplitudes were 0.00012 inch at the high frequency and 0.038 inch at the low frequency. At the time of initial rotor speed reduction, shaft excursions relative to the carrier were decreasing, possibly indicating a stronger, more rigid bearing. This may have been caused by overheating and increased air viscosity or interference from the overheating foil coating.

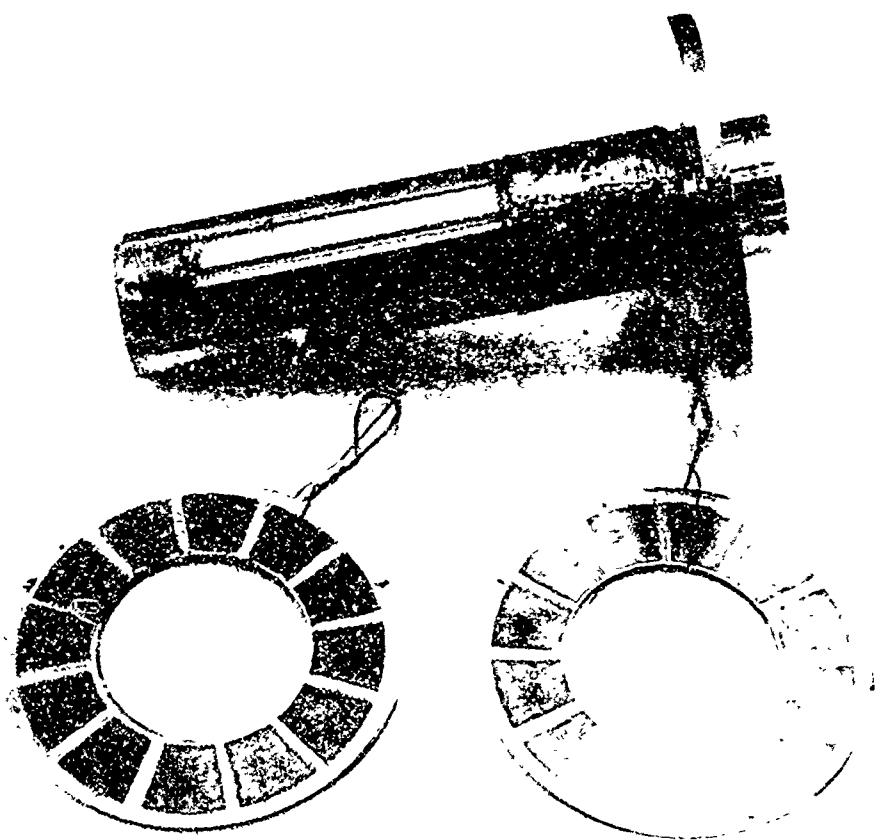
After the test, the unit was disassembled and inspected. The compressor journal bearing had failed and the foils were inertia-welded into the shaft. The remaining bearings, however, were in relatively good condition. No damage was incurred by the turbine or other parts of the unit except for the foils, the immediate bearing carrier, and the shaft.

Figure 45 shows the shaft as it came out of the engine. Slight residual damage is visible at the turbine bearing end of the shaft, which probably occurred after the front bearing failed and the shaft experienced large displacements. Slight damage is also visible at the inner diameter of the turbine thrust bearing, which is adjacent to the failed journal bearing where high temperature soakback damaged the foil coating.

Figure 45. View of shaft and two thrust bearings after disassembly upon completion of vibration test.

It is believed that two phenomena caused the forward journal bearing to seize before either of the other bearings. The first is that the centroid of the rotating group is axially located closer to the forward journal bearing than to the aft journal bearing. Secondly, the vibrational load path on the engine structure starts where the engine plenum is bolted to the vibration fixture. The plenum amplifies the input vibration with minimum displacement of "pivoting" at the installation location, which is just above the turbine wheel and very close to the aft journal bearing.

Results of the vibration test reflect largely upon the engine frame rather than the bearings. Aircraft installations require that the engine frame prevent multiplication of vibrational amplitudes from the source to the bearing carrier by provisions for adequate damping. Hence, results of the vibration test do not effectively evaluate the bearings, since many simultaneous conditions contribute to the vibrational characteristics of the engine.

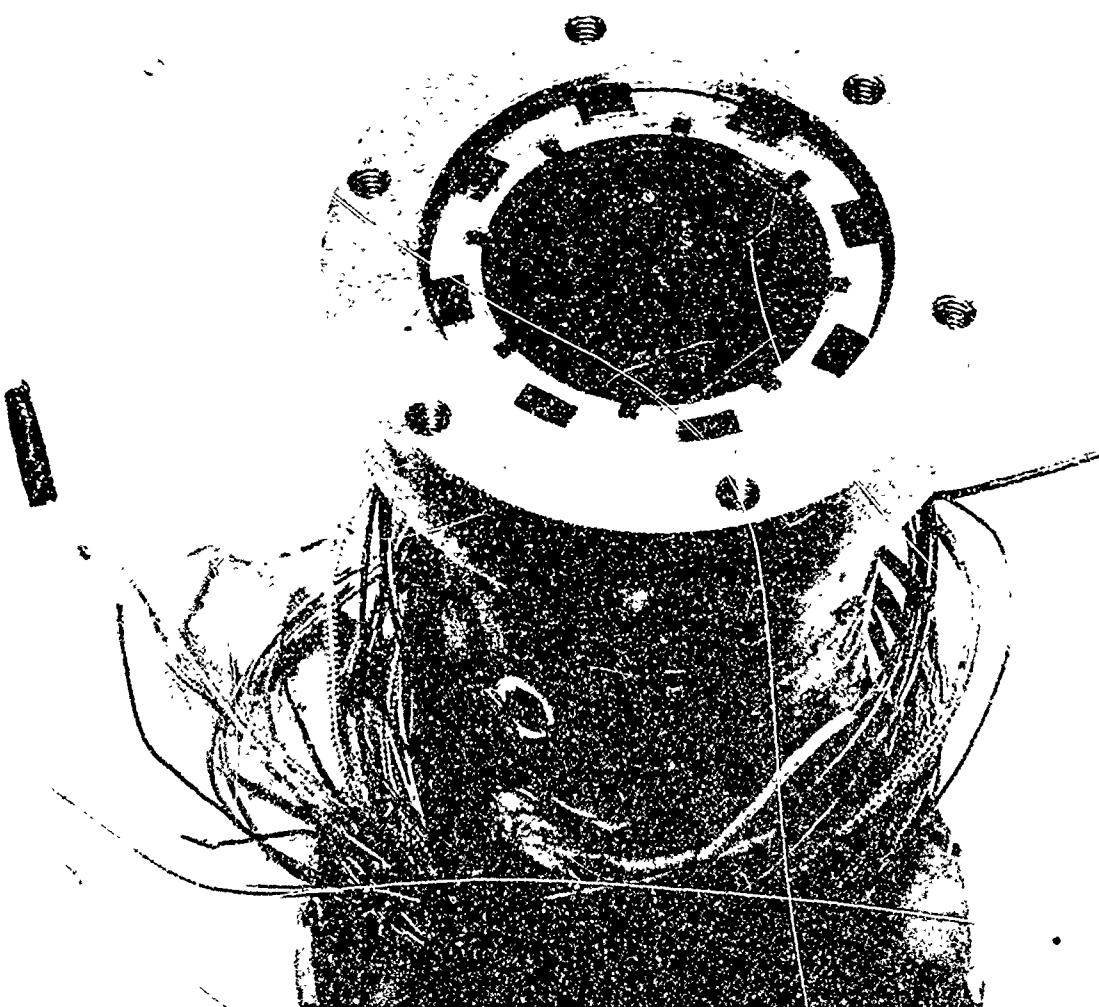
Figure 46 shows the remaining turbine journal bearing which is in relatively good condition although parts of the foil coating were scuffed. The bearing did not overheat and, from the color of the foil coating, did not experience temperatures above 500°F.

Figure 46. Close-up view of back (turbine) journal bearing.

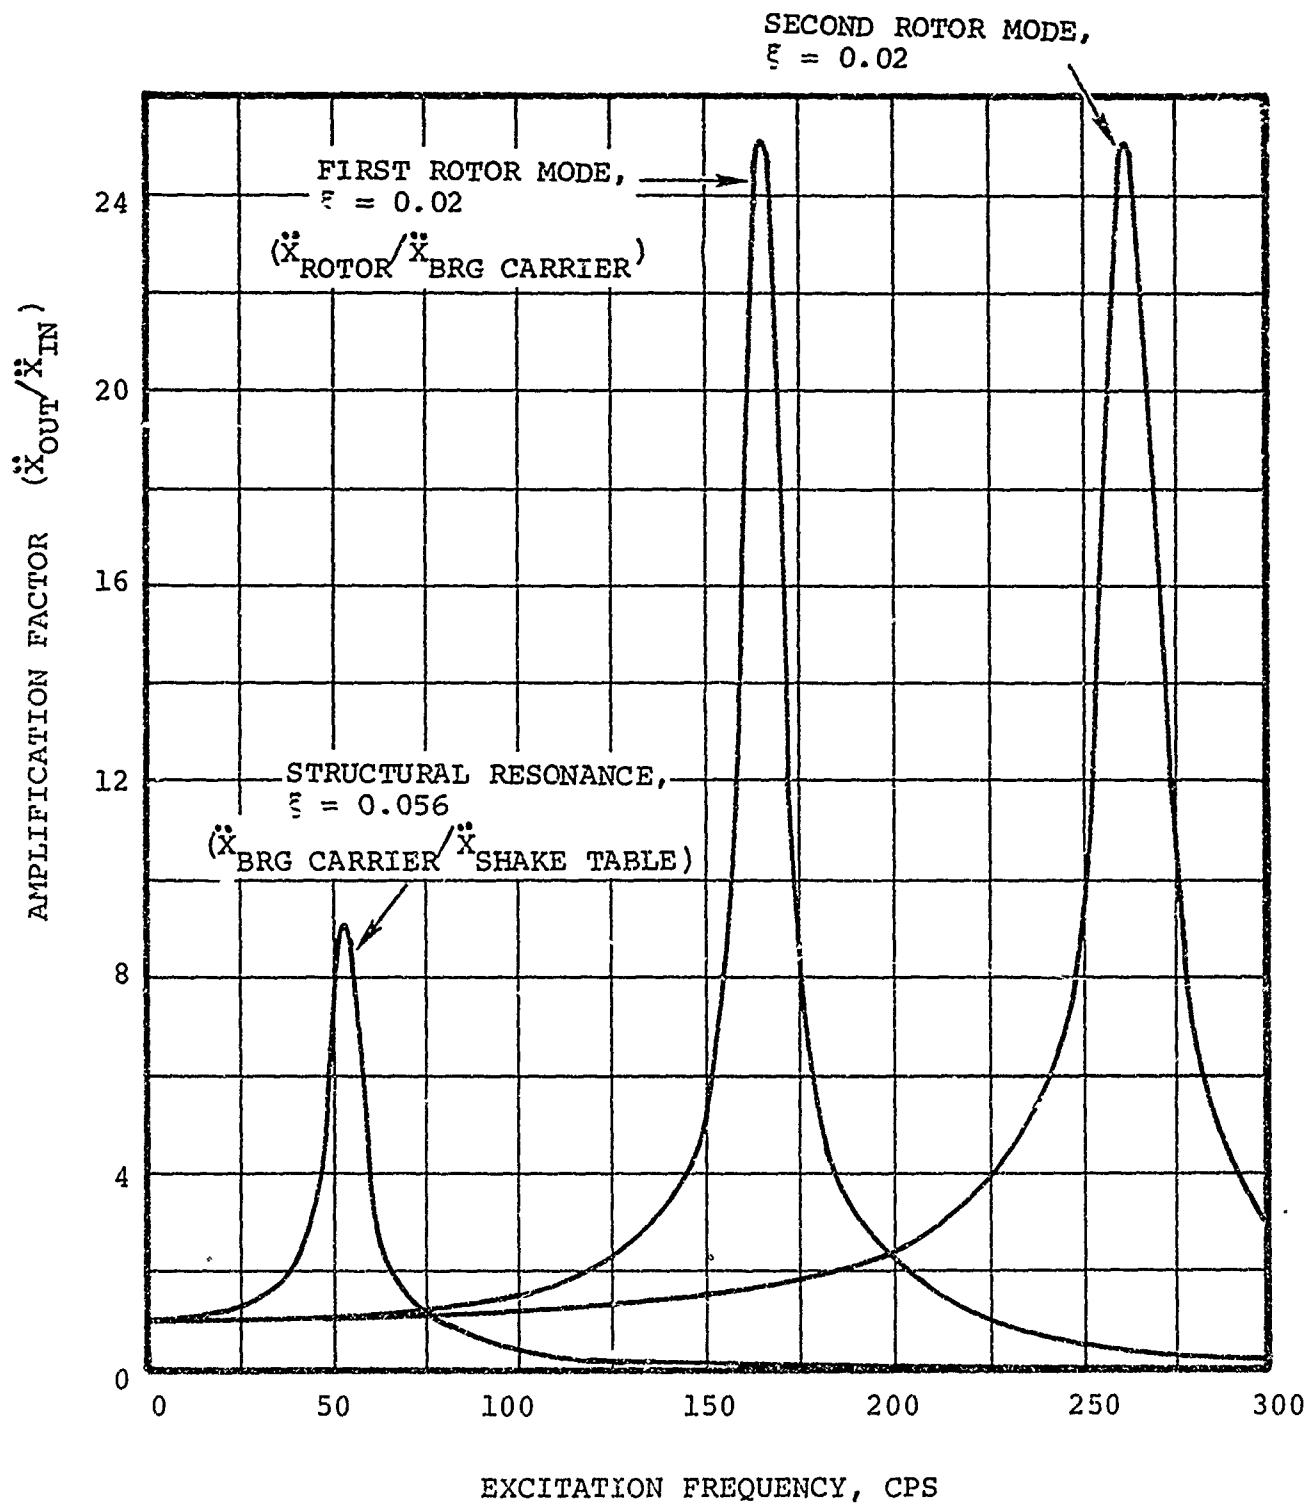
Figure 47. Single degree of freedom amplification factors.

A renewed critical speed analysis was conducted with the bearing springrates increased to 10,000 lb/in. rather than 5000 lb/in. used in the previous analysis presented in Figure 47. The new springrate was considered to be more realistic in view of the high shaft displacements involved. The resulting critical speeds were 166 cps (9970 rpm) and 262 cps (15,700 rpm). Figure 48 shows the amplification factors in a simplified single degree of freedom system with the above natural frequencies. The structural response was detected from the data of the vibration test. The rotor resonances were predicted from the critical speed analysis. Using the data from Figure 2, Figure 3 was generated to show the amplification factor of the rotor with respect to the shaker table. The peak amplification factors are 9.0, 2.9, and 1.1. The high reduction of the two rotor resonances (critical speeds) results from isolation by the structure. This leads one to believe that the structural resonance of 53 cps at the bearing carrier is the worst vibrational loading condition for the bearings, had the unit survived the entire vibrational scan. However, there may be other structural resonances which more closely match the rotor critical speed frequencies, not providing the isolation shown in Figure 3. A problem such as this would require development to "tune" the structural frequencies away from critical speed frequencies.

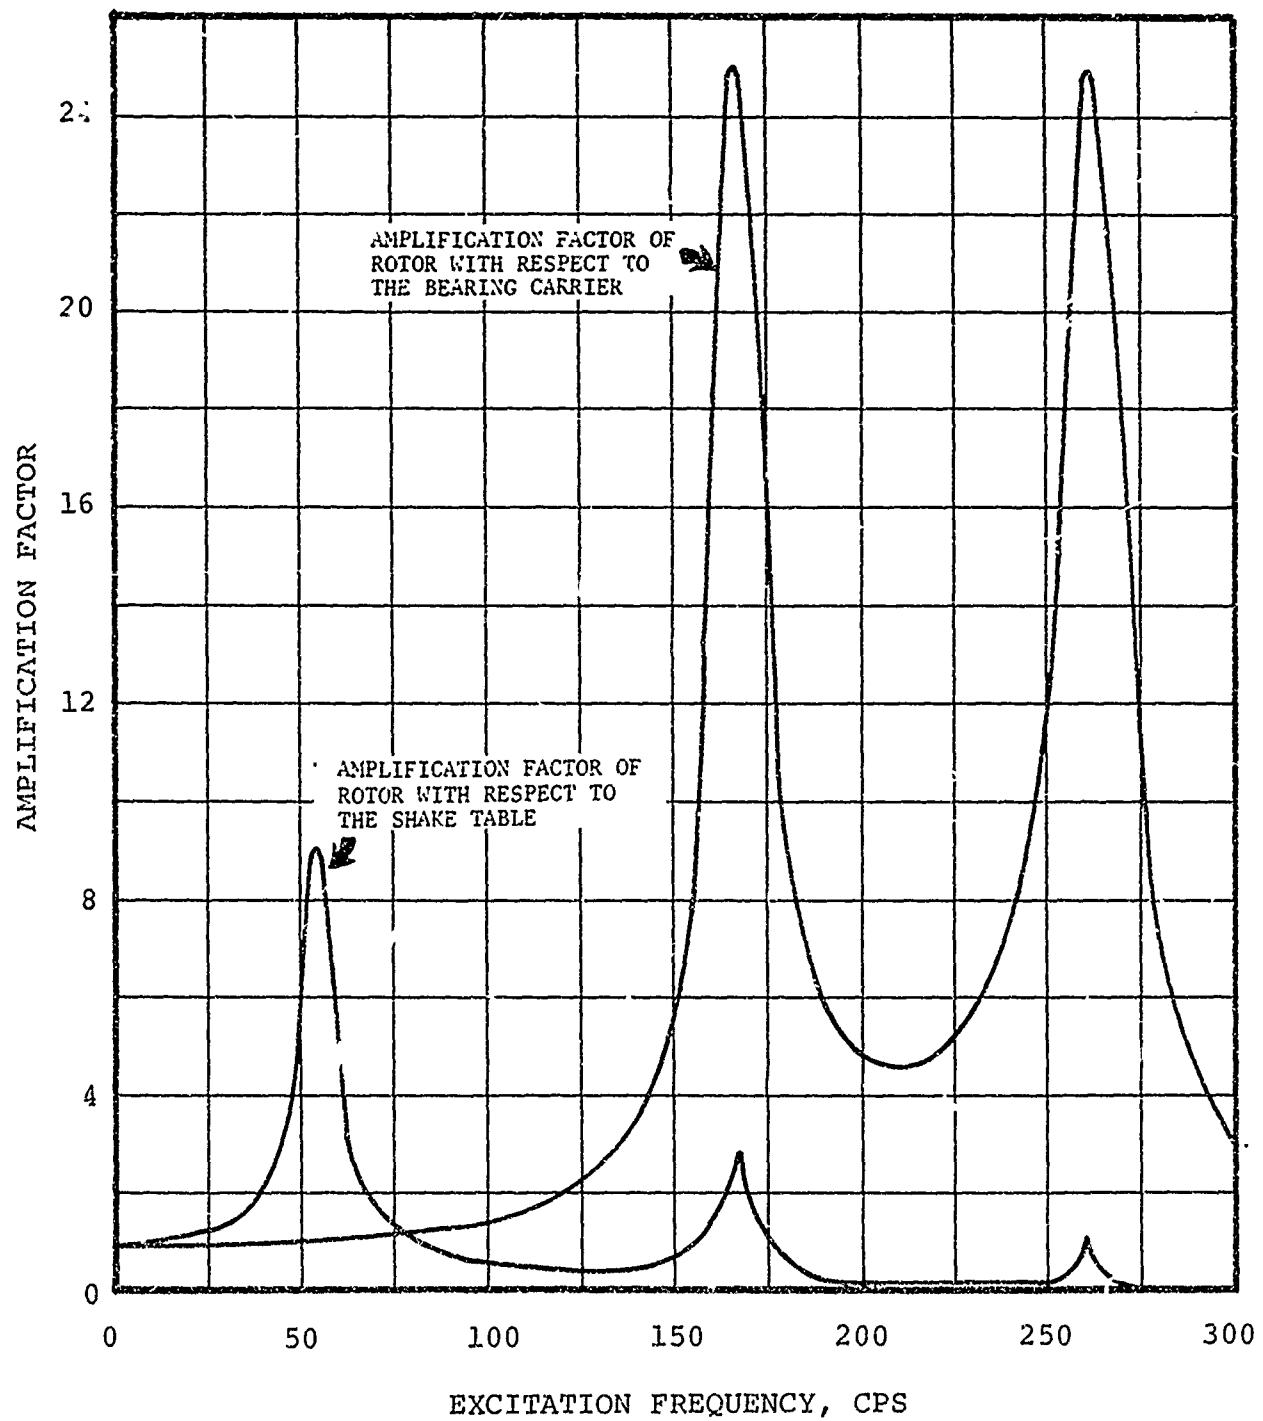
Figure 48. Estimated system amplification factors.

Structural frequencies in the engine, which can multiply the g-loading to the bearings occur on many engine structures and can become a development problem independent of the rotor/bearing natural frequencies. The original JFS100-13A utilizes a relatively thick-walled plenum made from a magnesium casting. The plenum used on the foil bearing demonstrator was made from Type 321 stainless steel, and had a much thinner wall than its cast production counterpart. The thinner wall consequently would exhibit sharper natural frequencies, with greater deflection and less damping.

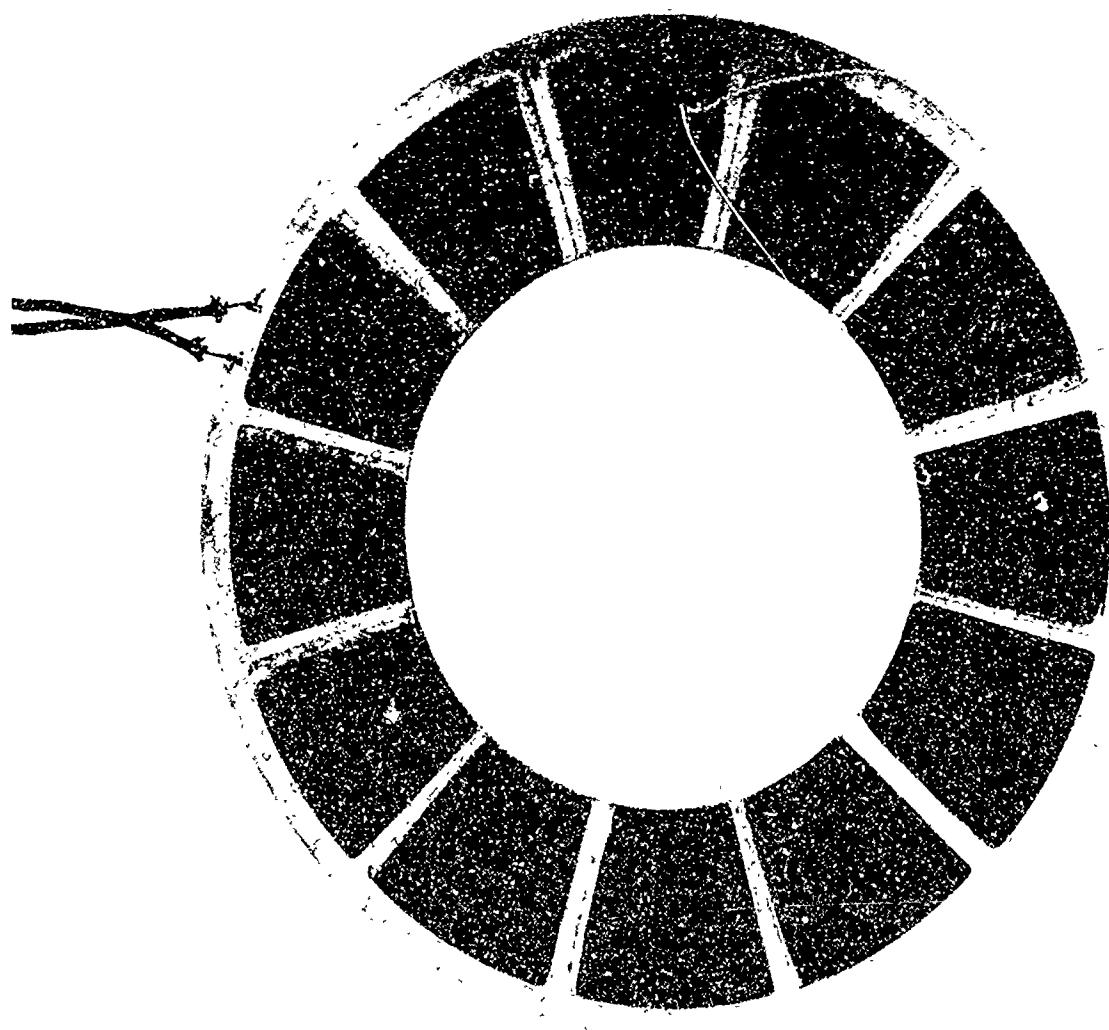
Figure 49. Thrust bearing thermocouple location.

The small thermocouple, installed in the thrust bearing as shown in Figure 49 (as located in the overtemperature test), indicates temperature by air convection from the central part of the bearing. Temperature influence is obtained from the swirling air that is leaving the bearing and which has been heated from the constant viscous shearing inside the bearing. Due to high air speed, the convection (heat transfer) rate is expected to be high, and the temperatures indicated by the thermocouple should be approximately the same as those in the center of the bearing. During shutdown, however, and near the end of shaft rotation, air speed, and therefore convection, is low and the temperatures at the thermocouple are lower than the maximum temperatures generated in the bearing.
